Motor Vehicle Forensic Analysis Report

People of the State of New York v.
Nauman Hussain

REFERENCED INVOLVED SUBJECT VEHICLE: 2001 Ford Excursion Stretch Limousine,
VIN 1FMNU40S51EB10299

DATE OF CRASH: October 6, 2018 @ 1355 Hours

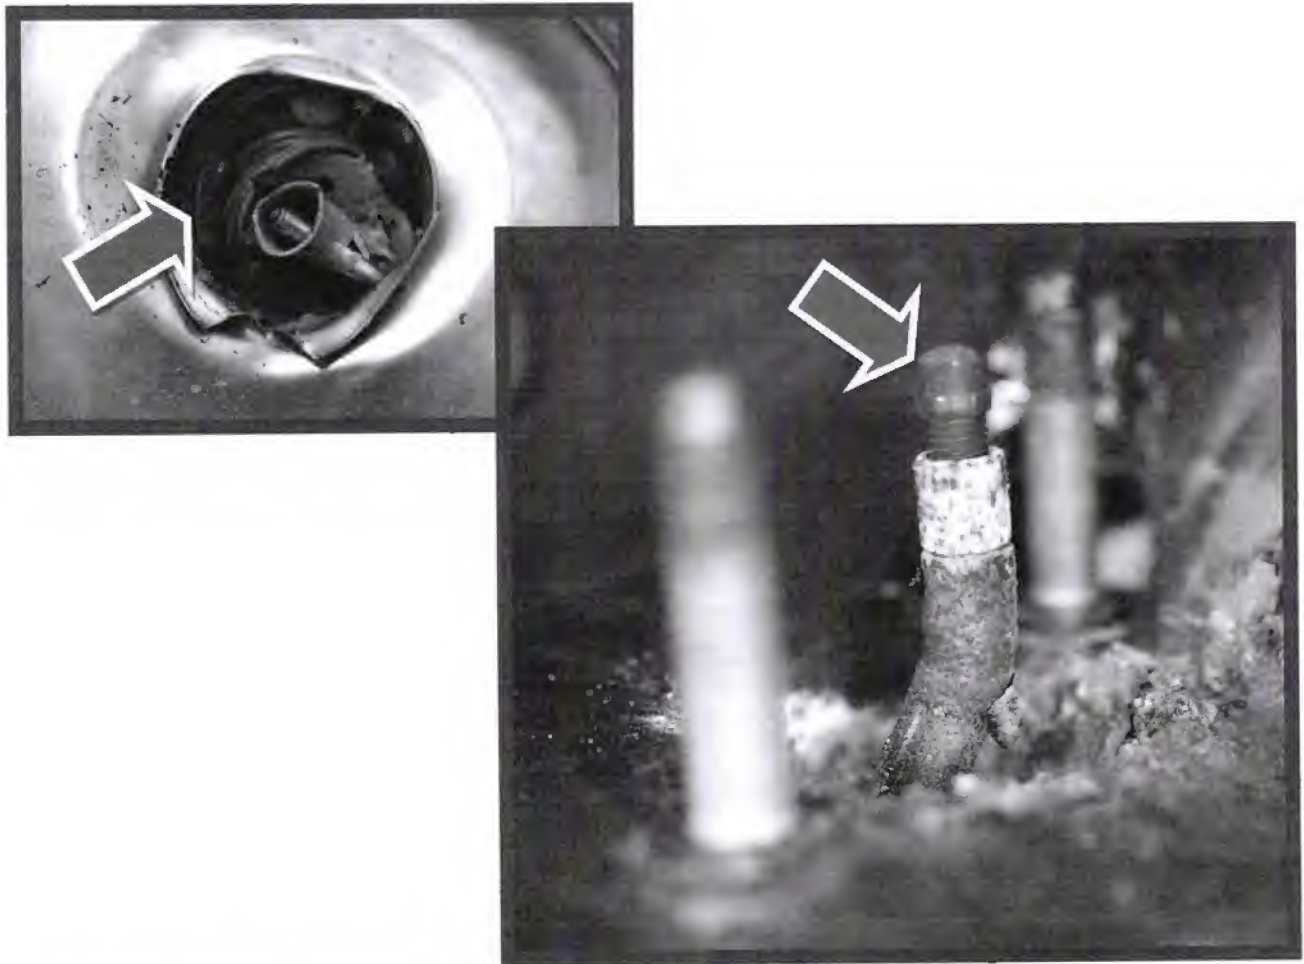
Image No.41a & 41b. These photographs depict the brake master cylinder push rod (lower photograph) and the power brake vacuum booster of the 2001 Ford Excursion stretch limousine during the period of individual component analysis. The state of compression of the internal power brake vacuum booster (Red Arrow), and the extended position of the brake master cylinder push rod of the power brake vacuum booster (Blue Arrow), are consistent with that of brake pedal depression by the vehicle operator at the time of impact, which seized the components in position.

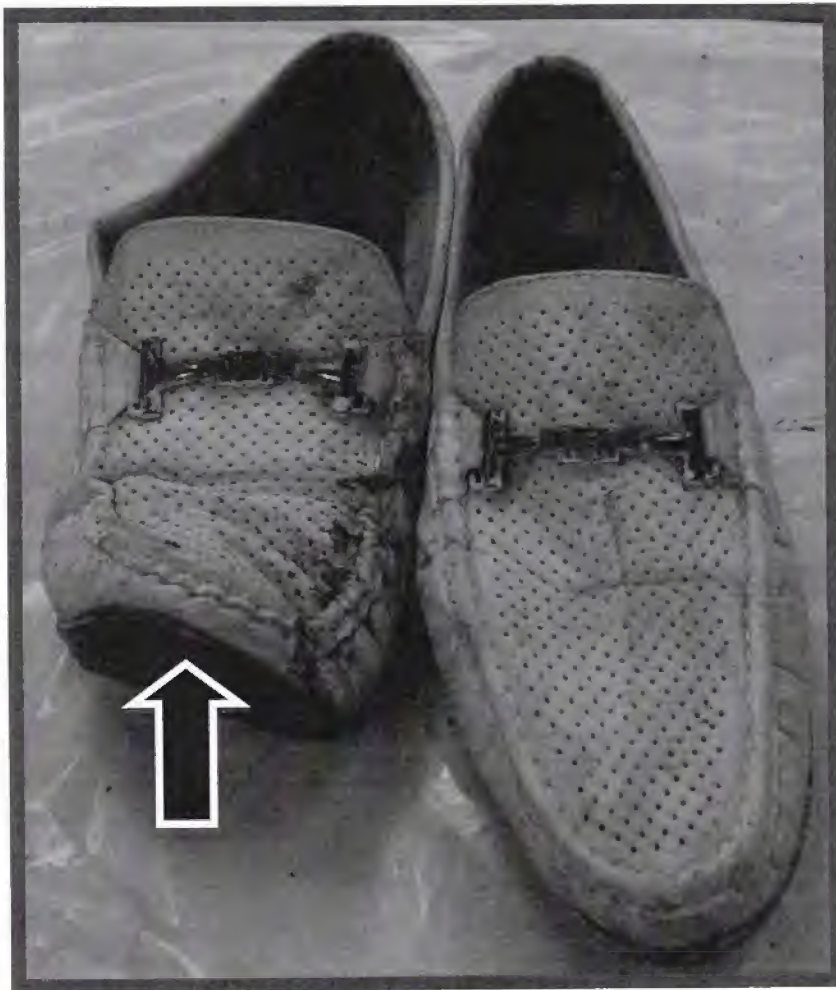
Image No.43. This photograph depicts the shoes worn by the operator of the 2001 Ford Excursion stretch limousine at the time of the crash on October 6, 2018 in Schoharie, New York. Note that one of the shoes exhibits remarkable deformation at the forward section (Black Arrow), consistent with that section of the foot providing brake pedal depression at impact.

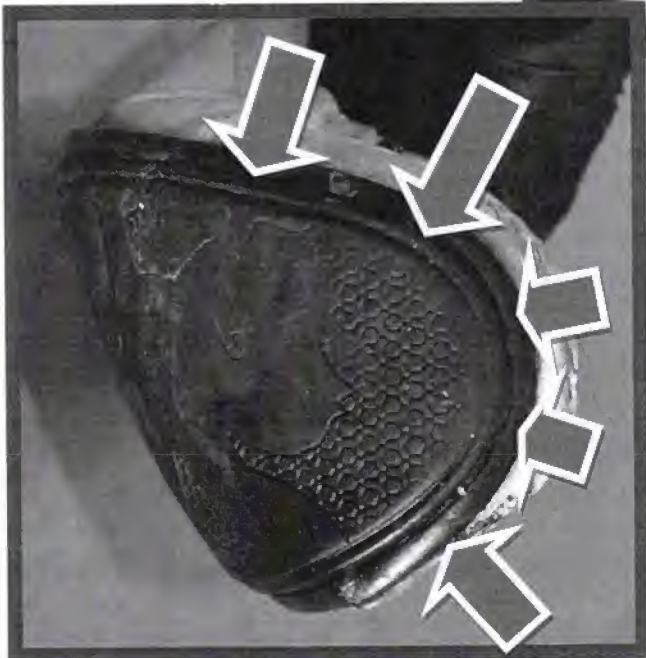
Image No.44a & 44b. These photographs depict the rubber composition brake pedal pad of the 2001 Ford Excursion stretch limousine during the period of individual component analysis (above photograph; and the shoe worn by the operator of the vehicle at the time of impact on October 6, 2018 in Schoharie, New York (left photograph). Note the semi-circular depression imprint of the brake pedal pad (Orange Arrows), which is consistent with the shape of the deformed shoe worn by the operator of the vehicle.
